# Community Archaeology Excavation Report

## **Greyside Abandoned Farmstead, Newbrough, Northumberland**

**Excavation 11<sup>th</sup> – 14<sup>th</sup> March 2020  
and 7<sup>th</sup> – 10<sup>th</sup> March 2022**

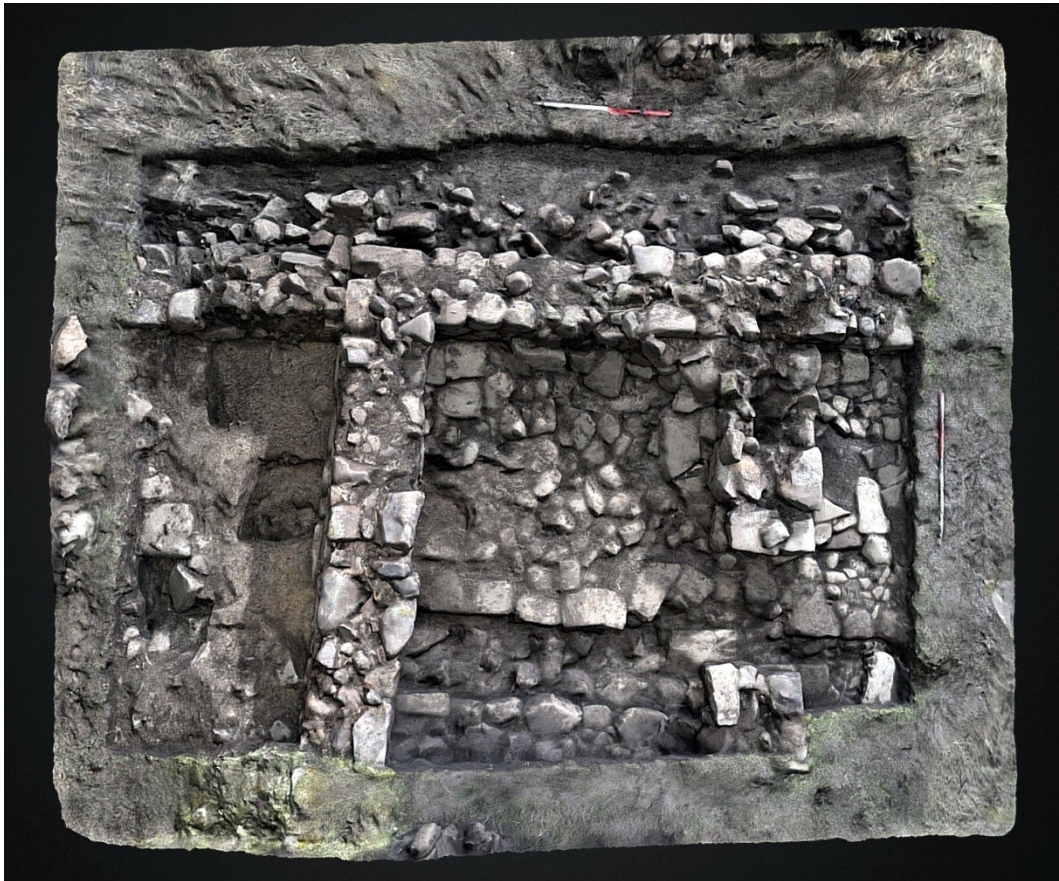
**Vertical photogrammetry view of 2020 trench. North at top. Ranging poles are 1m.**

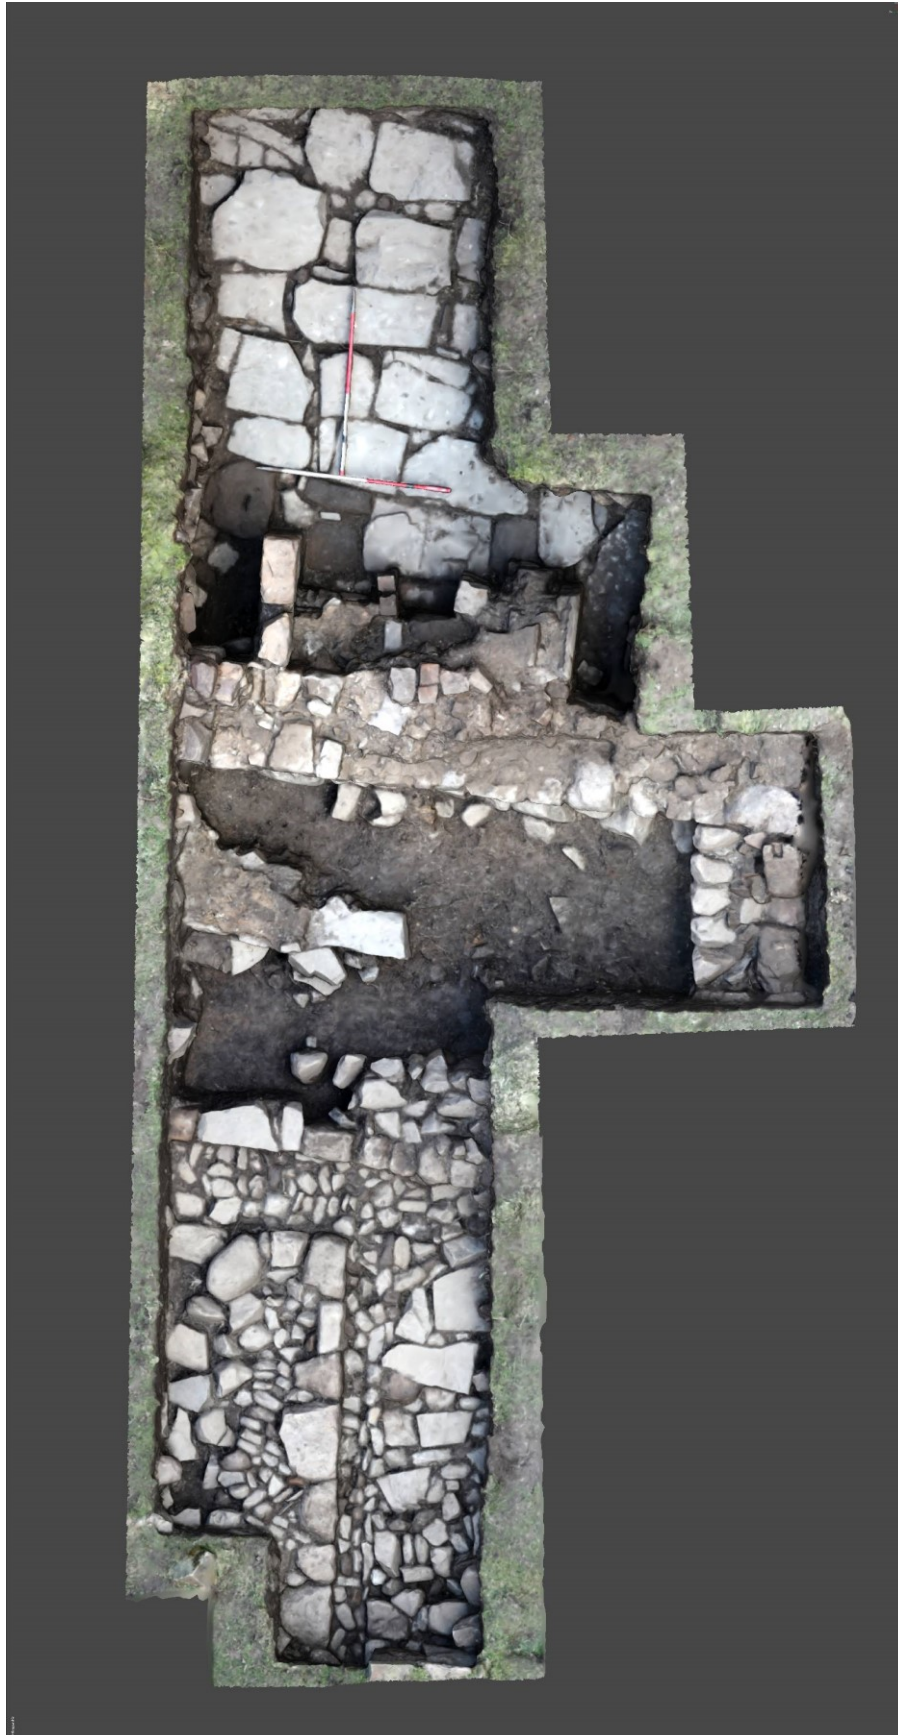
**Vertical photogrammetry of the 2022 main trench. North at left.**

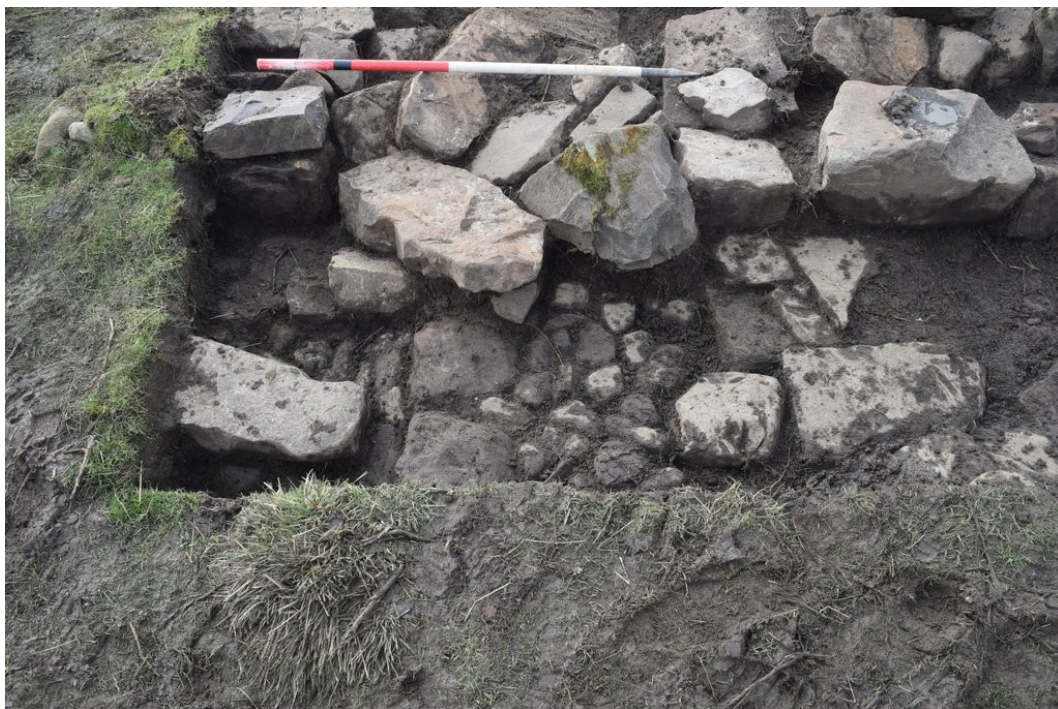
The gap in the cross-wall, looking west. The 1m ranging pole is placed across the gap. The rubble blocking the gap is still in place under the pole. In the rubble are some long (0.7m) flat stones which may have been lintels (see discussion section).

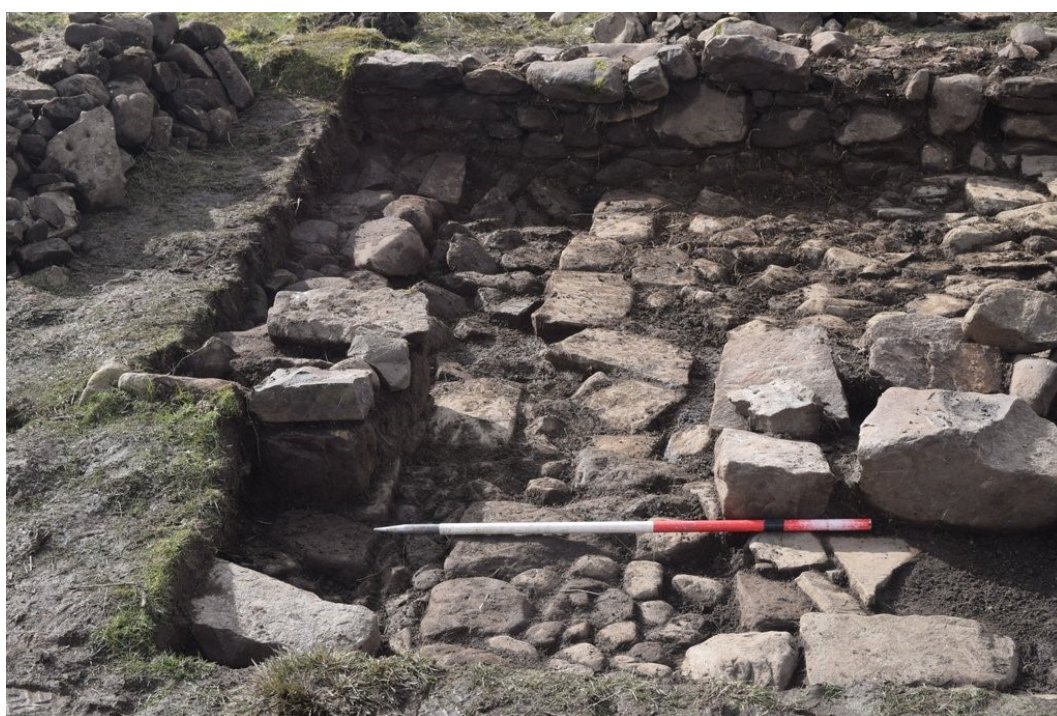
The gap, after removal of rubble. Photograph from same position as previous photograph.

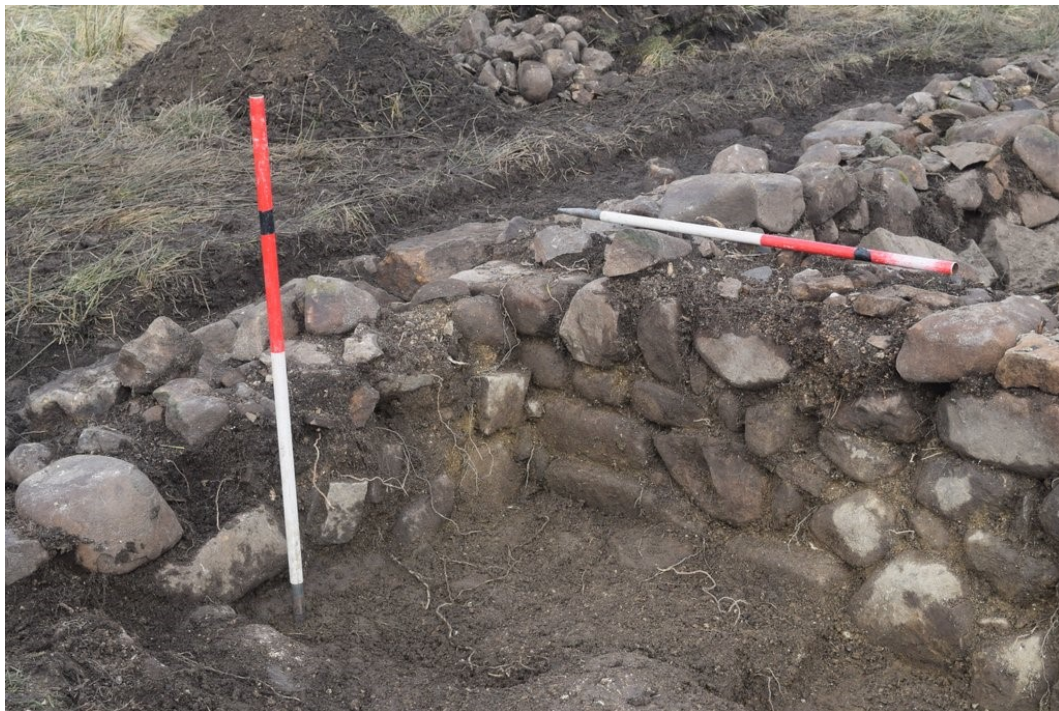
Close-up of north end of west wall, showing join with north wall of western compartment (on left). See next photograph for a view of this wall-joint from the other side.

Examination of the walls showed that the north wall of the western compartment abutted the NW corner of the central compartment. Similarly, the south wall of the central compartment abutted the SW corner of the eastern compartment, which had a large quoin. Thus, the three compartments were clearly built in phases (as discussed below), not as a single structure.

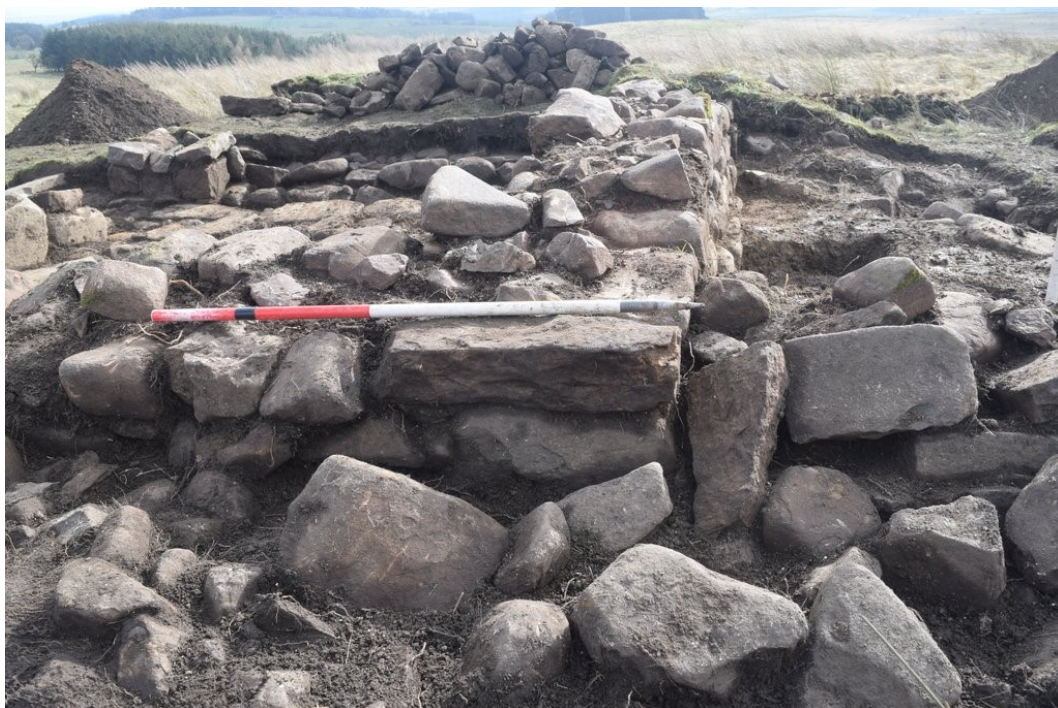
North-west corner of central compartment, seen from outside, looking south.  
Shows join with north wall of eastern compartment (on right).

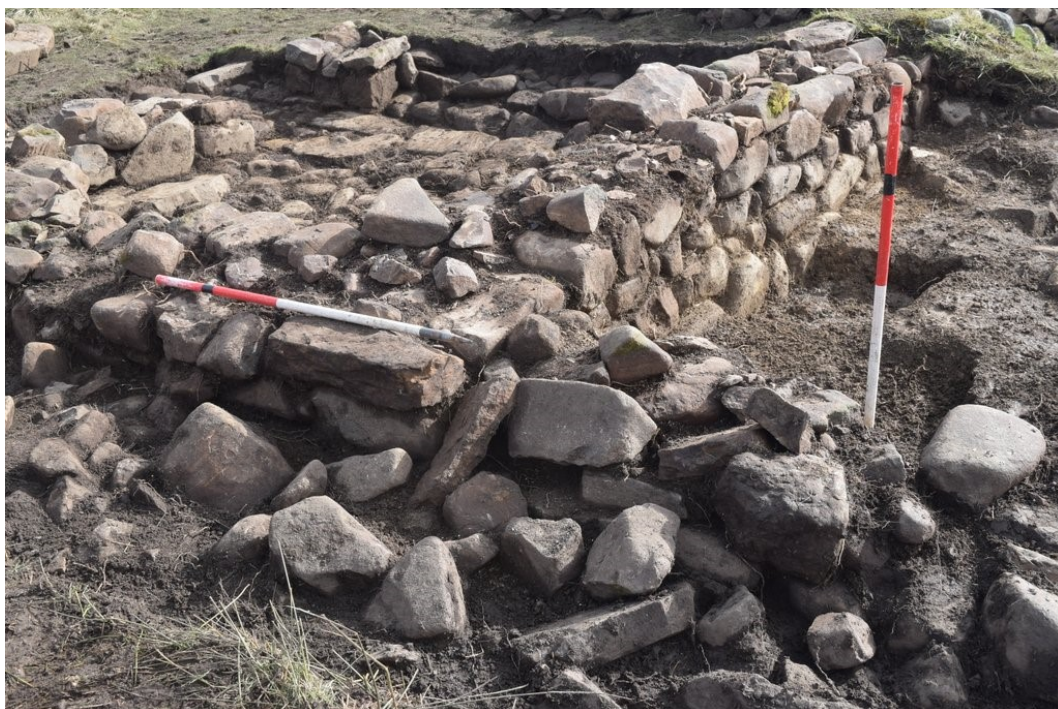
Same wall-join as previous photograph, diagonal view looking south-east.

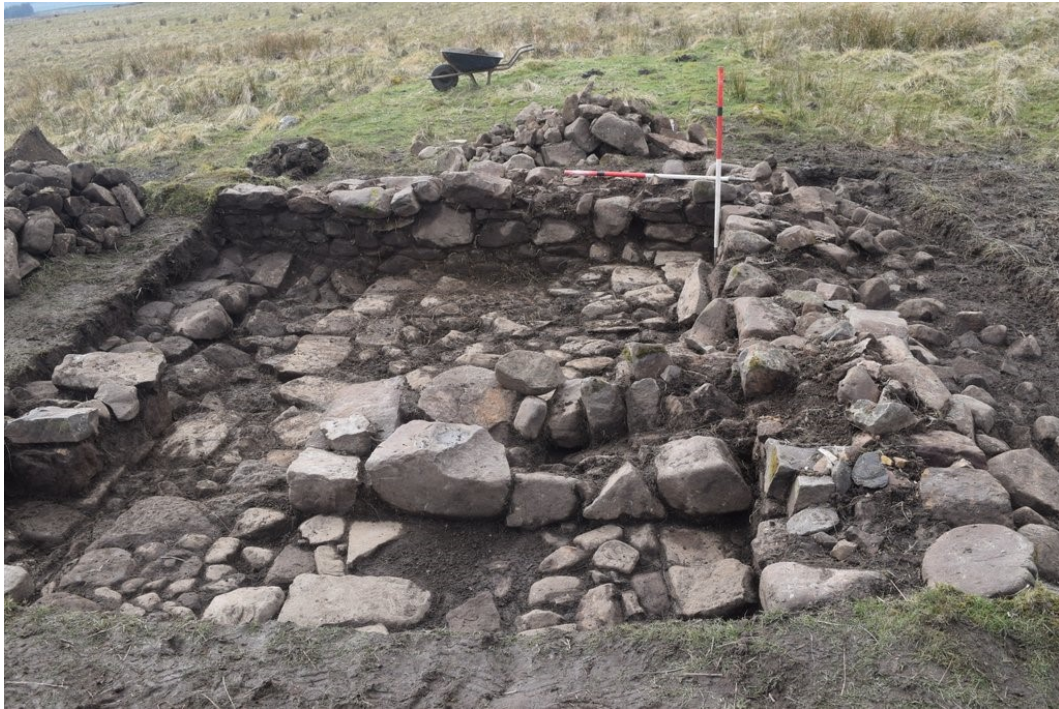
Interior of central compartment, looking west at end of 2020 excavation. Shows join between cross-wall and (on the right) the north wall.

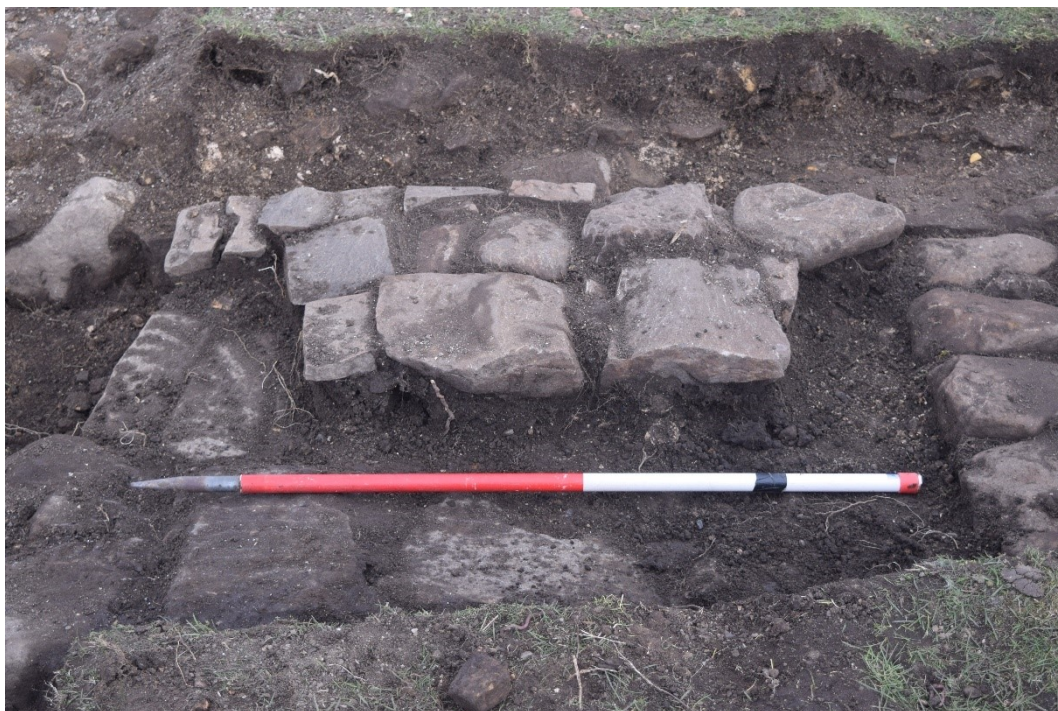
The fragmentary upper flagstone surface, forming a raised platform abutting the gable wall at the east end of the central compartment, looking east. Some stones of the fragmentary lower flagstone surface are also visible. The inner face of the south wall is on the right.

The eastern part of the central compartment is clearly different from any other part of the building excavated. In sequence (from top down) there was rubble from collapsed walls, then a thin soil layer, then a fragmentary upper flagged area, then a thin (5cm deep) dark loose deposit with coal and cinders, then another fragmentary flagged area, then more dark loose deposit with coal and cinders, and (at the bottom) the clay-rich subsoil. At all levels (including under the lower flagged surface) there were post-medieval pot-sherds (see Finds section). The upper flagged area covered 1.2m (N-S) x 0.6m (E-W) in the SE corner of the compartment. The lower flagged area was larger, covering the easternmost 1m of the compartment. Both flagged areas were loosely laid on uncompacted material, so were probably platforms for storage rather than floors. Most of the flagstones were unworn. In addition, there were several patches of mortar, one of which extended under the south un-mortared wall of the building. Another patch was left un-excavated and can be seen in the photogrammetry image, lying on the lower flagged surface. These were possibly where mortar had been mixed for repair work.

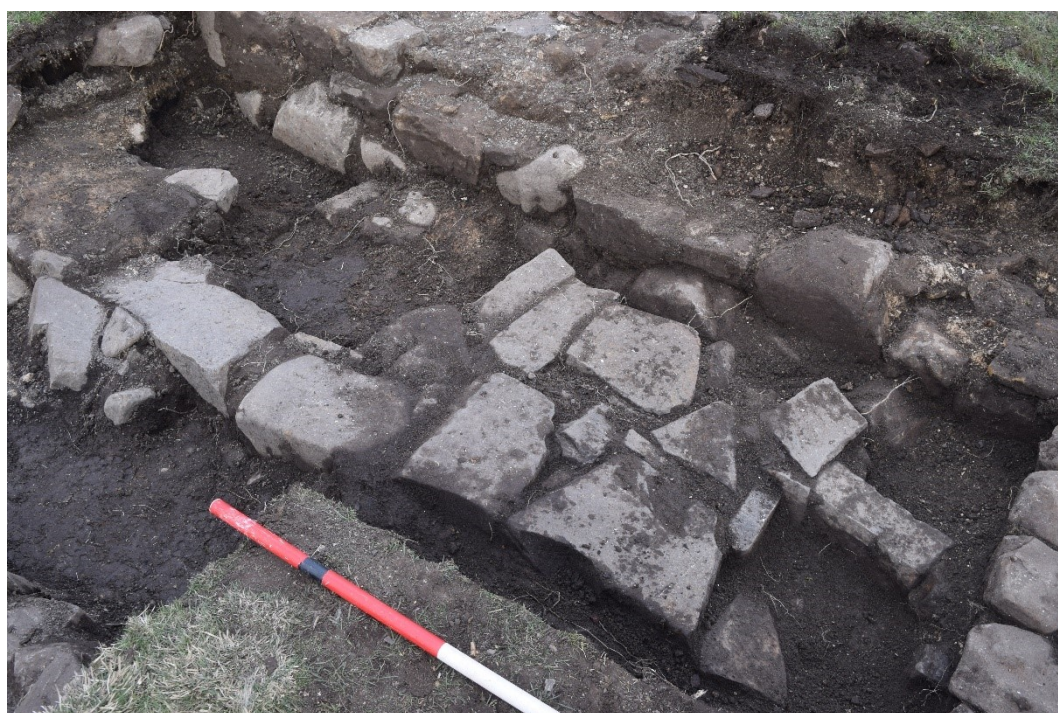
After removal of the upper flagstones, and the loose dark deposit underlying it, the lower fragmentary stone surface is revealed. At far left is a spread of mortar lying on this floor.

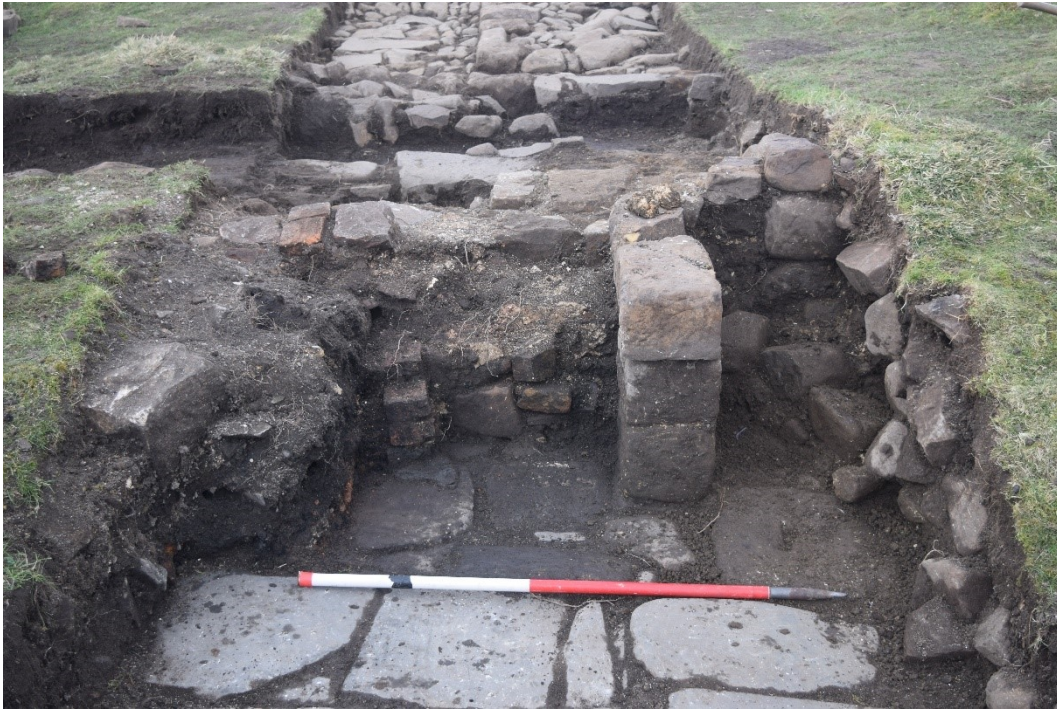
The fireplace under excavation, showing north wingwall of stone blocks and in-filling of loosely placed bricks, mortar and stones in a dark matrix smelling of cinders.

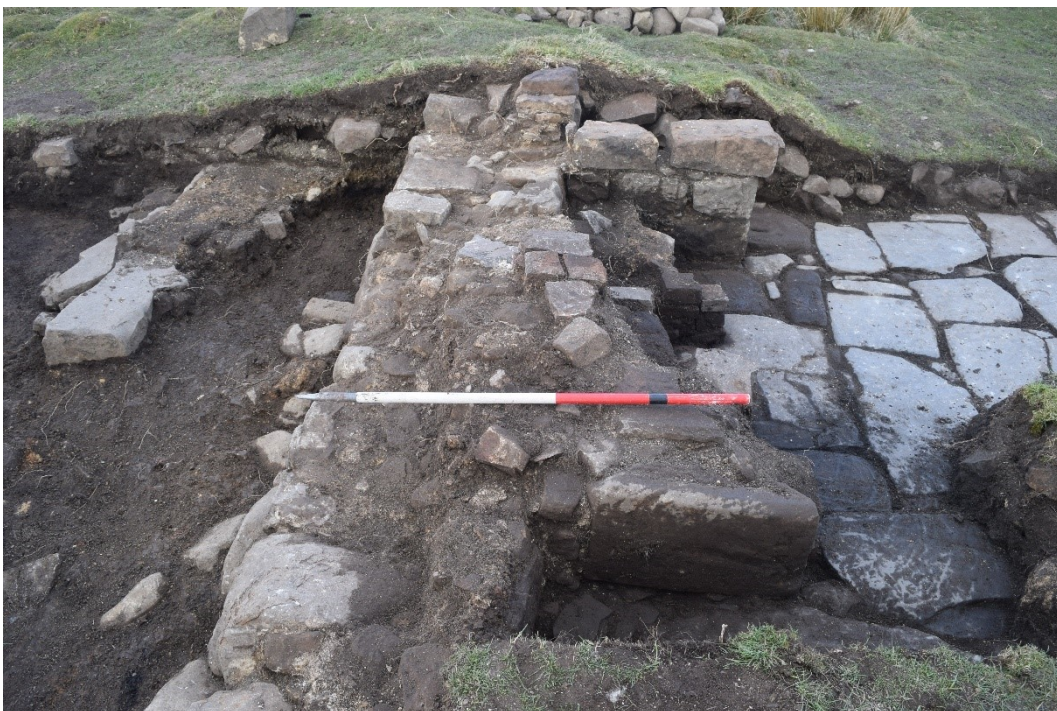
The fireplace, looking north. Note the “Roman” masonry of the north wingwall, unlike any other wall excavated.

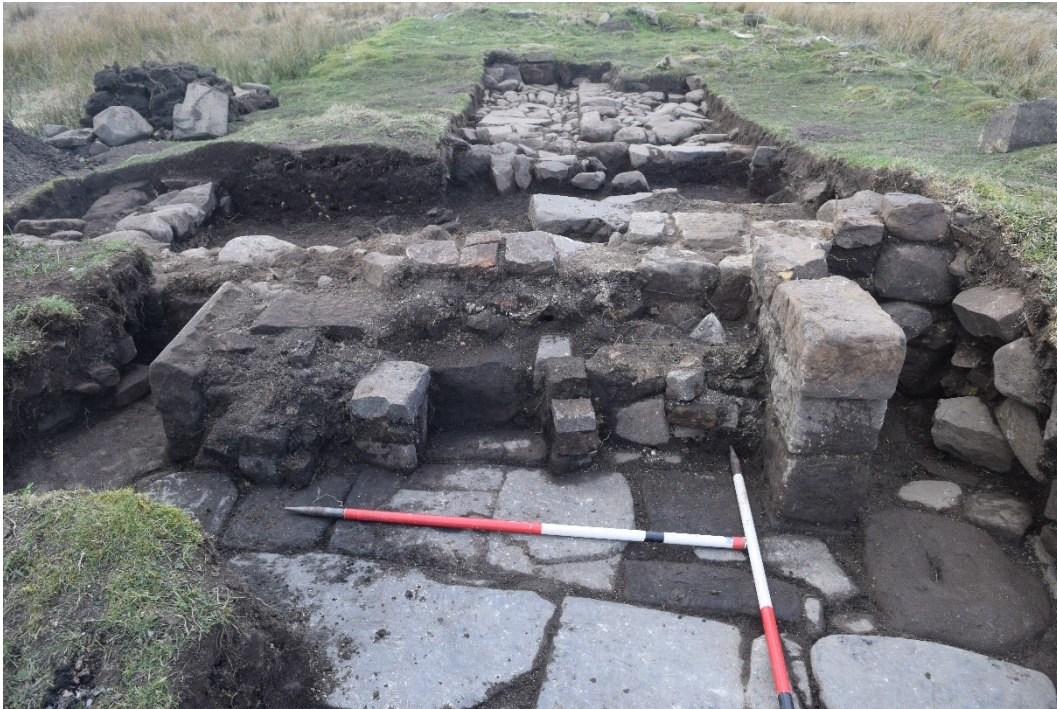
The fireplace at the end of the excavation, showing the in-fill restricting its size to a third of its original width. Note the stone with slot in it (a possible grindstone roughout) re-used as a floor-stone to the right of the right (north) wingwall.

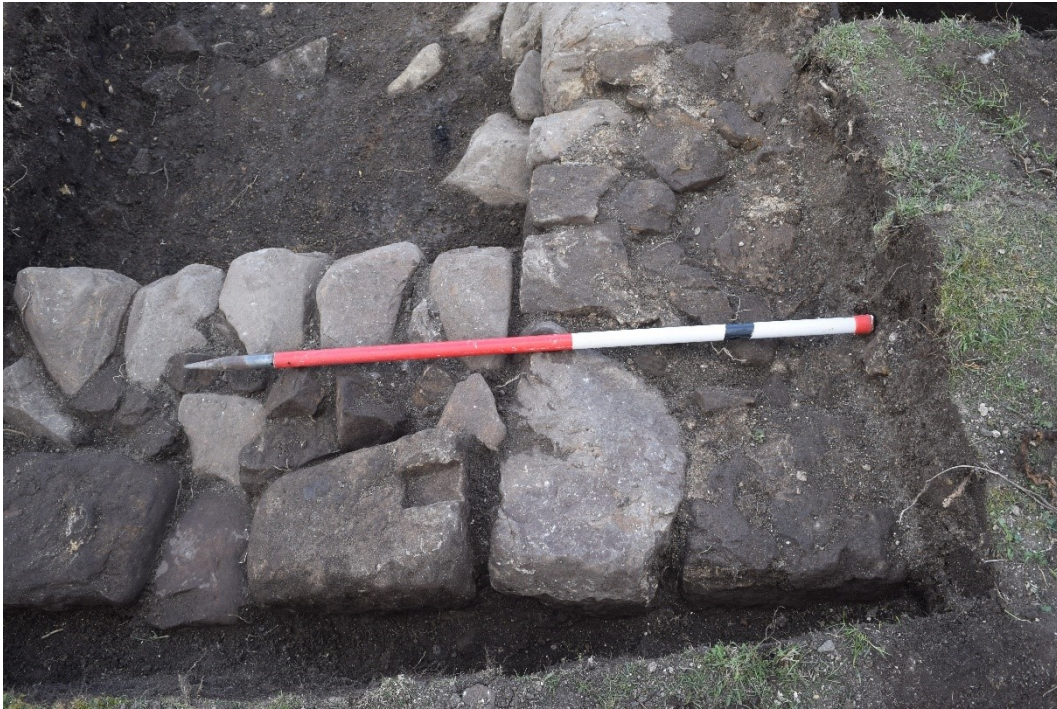
The SW corner of the eastern compartment (to right and upwards) formed of mortared rough stonework, with a large quoin. Abutting it, to the left, is un-mortared south wall of the central compartment. One of its stones has a slot cut into it; it may have previously supported a door-post before being re-used.

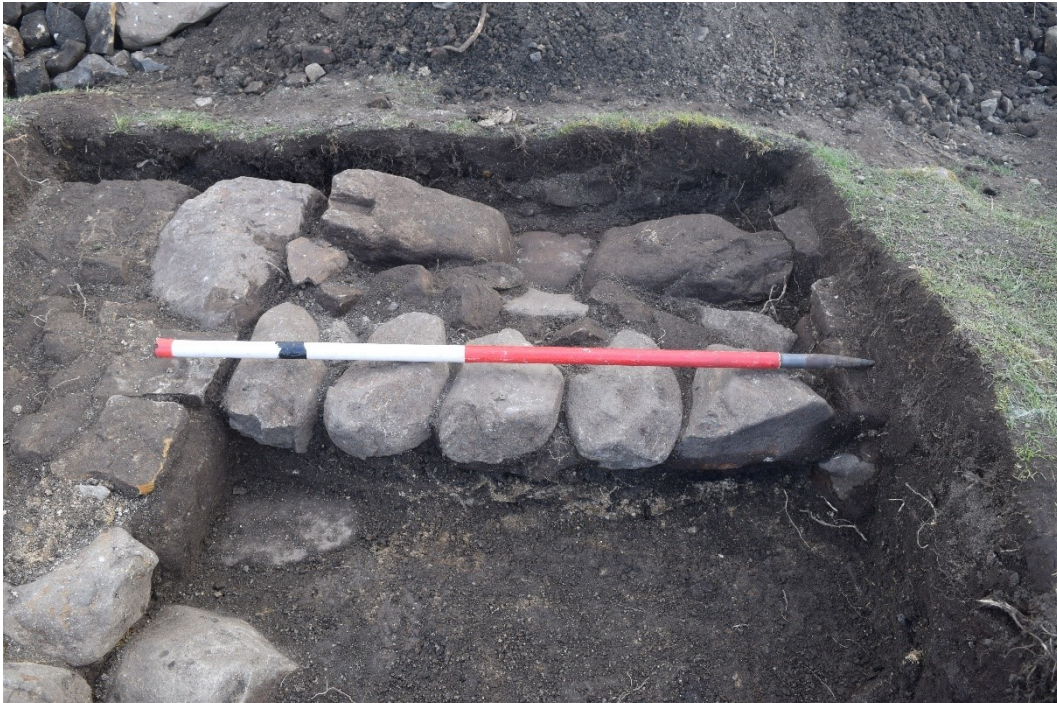
The same corner from the opposite side, looking south. Although the south wall is un-mortared, there is a lens of mortar-rich material beneath it. The base of this wall is at a higher level than that of the wall-corner that it abuts, suggesting it is a later phase.

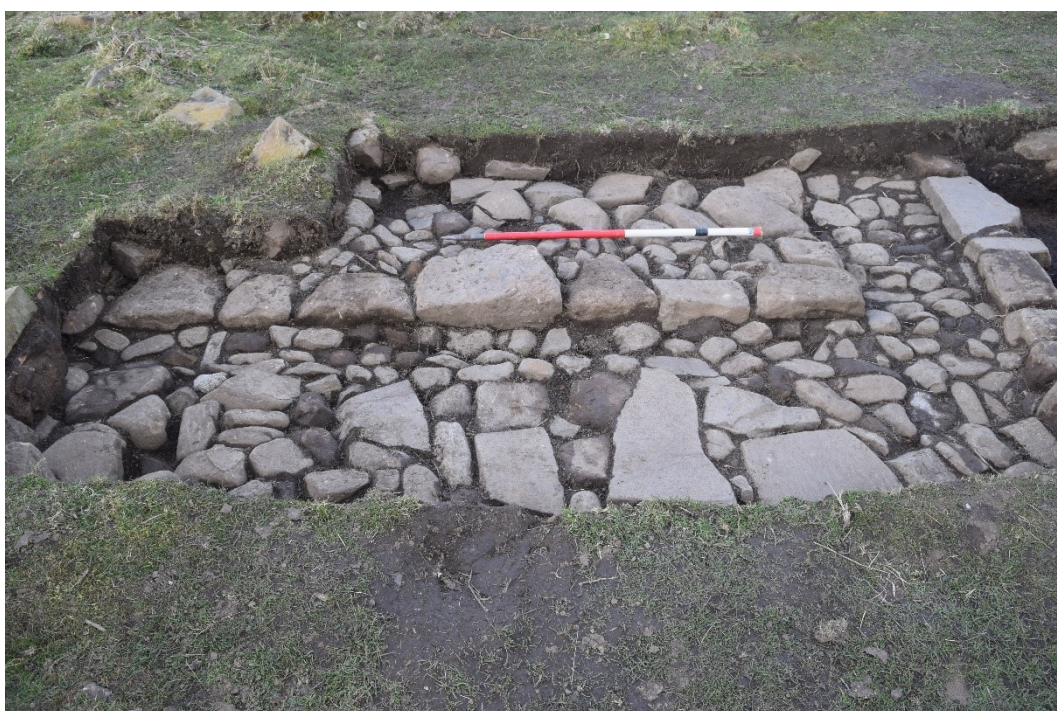
The floor of the byre excavated in 2022, showing the central cobbled drain.

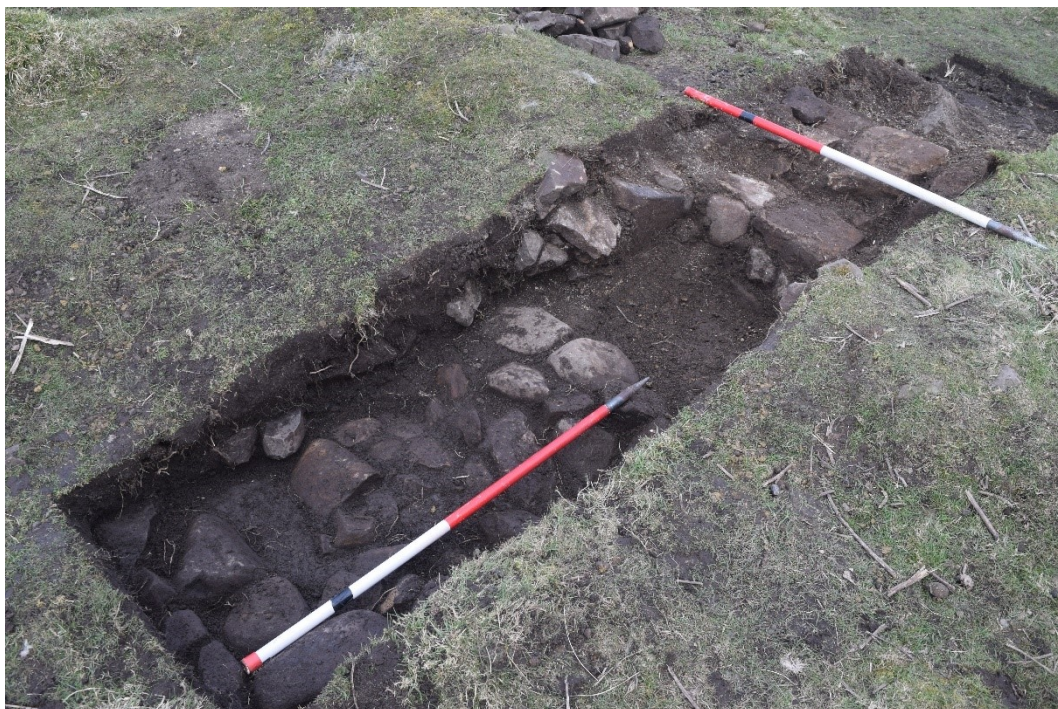
At the end of the 2022 excavation, the small east trench, showing the floor at the east end of the eastern compartment, with the upper ranging pole along the line of its east wall.

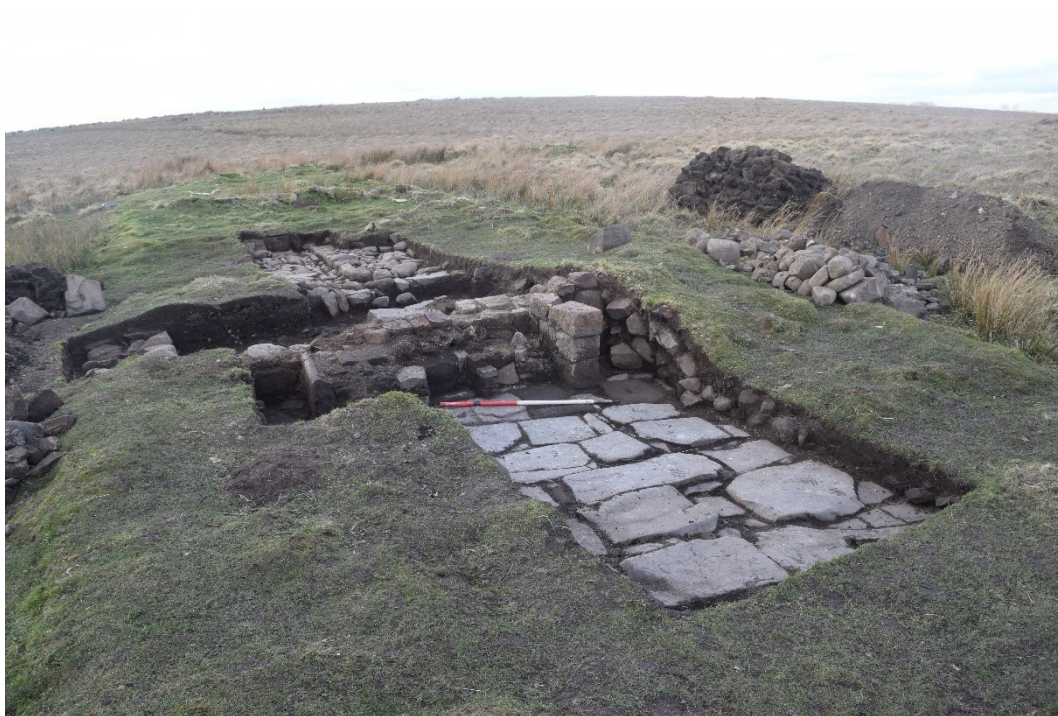
The main trench at the end of the 2022 excavation, looking NW. In the foreground is the flagstone floor and fireplace of the western compartment. Beyond it is the byre.
