# Community Archaeology Survey of a Farmstead Site at Rattenraw Farm, Redesdale May 26<sup>th</sup>-28<sup>th</sup> 2019

NORTH OF THE WALL  
**TYNEDALE  
ARCHAEOLOGY  
GROUP**

# 1. Introduction and Acknowledgements

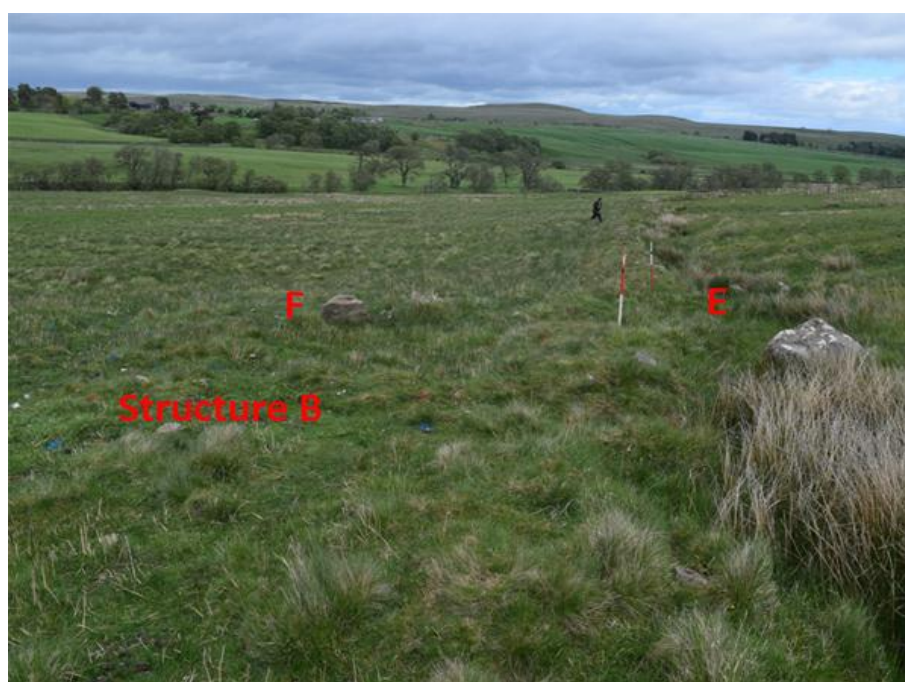
**Fig.5 Alignment of E-W bank and structure R38B looking east**

3.1 One of the key questions concerning the site is the physical relationship between the extensive east-west bank and structures R38 and R36, in particular whether the structures pre-date or post-date the bank. Close visual examination of the alignment of the bank suggested that it may diverge very slightly, by less than a metre northwards, where it coincides with the southern edge of structure B within R38, although this is far from conclusive as the boundary over its whole length does not follow a straight line. Examination of locations where the north-south banks of R38 and R36 meet the east-west bank was also inconclusive.

3.2 We did observe that along parts of the southern side of the east-west bank there are lengths of well-constructed stone revetting similar to that visible on banks to the east of the present-day farmhouse. Although there is a ditch along the southern side of the bank it is clear that the bank itself is not a sod-cast structure. We also noted indications that there must have been considerable robbing-out of stone from structure R38B and along the probable east bank of the yard/enclosure boundary.

Although the survey has not produced definitive evidence, we do feel that on the balance of probabilities structures R35-R38 pre-dated the east west bank, had fallen out of use, and that stone from them was used in the construction of the bank.

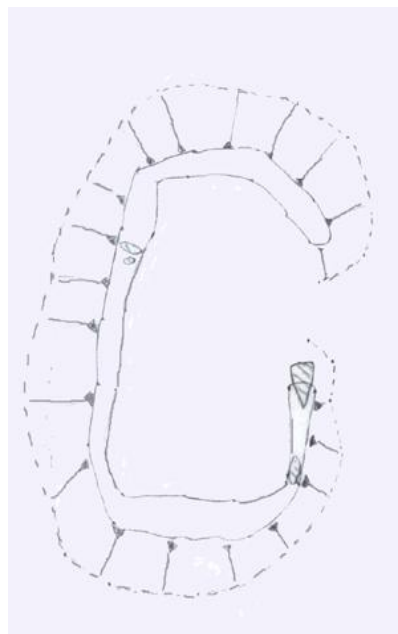
**Fig.7 R35 plan drawing**

3.13 15m west of the western end of yard/enclosure R38 lies a rectilinear structure, R35, with bowed ends. It measures 10m x 6m and has a possible east-facing 1.5m wide entrance. In addition to a number of visible stones, the perimeter has a continuous series of sub-surface stones. A striking feature is the lack of any internal change of slope from the perimeter bank. The plan drawing is shown as Figure 7 below. In 2018 we had suggested that R35 may be a stack stand because of the raised interior, but on closer examination this is most unlikely, given the amount of stone in the perimeter and the possible entrance. The remains recorded would not be incompatible with a shieling building which could have potentially pre-dated the possible farmstead. It should also be noted that such an interpretation would not exclude the possibility that the structure was subsequently re-used for some purpose during the period of occupation of the farmstead.

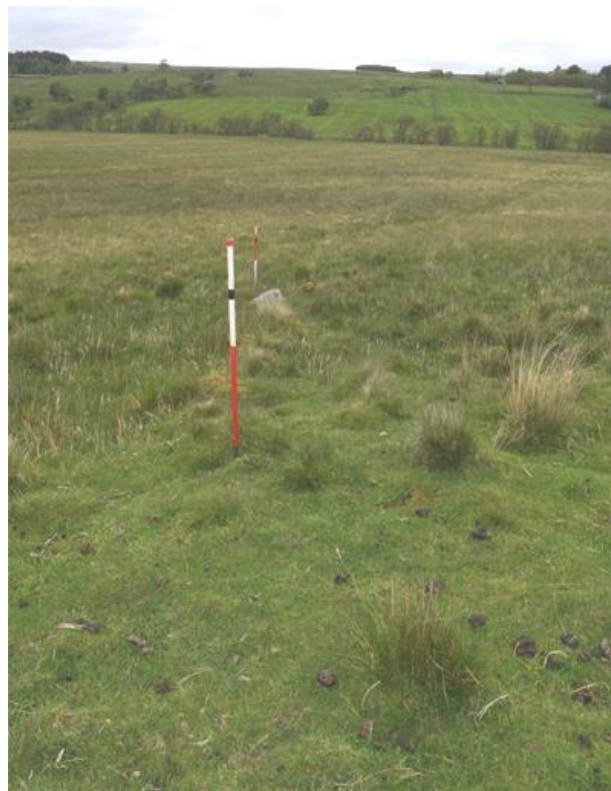
**Fig.9 Linear field boundary (Iron Age/Romano-British)**

3.15 Whilst checking the surrounding terrain for further features we identified lengths of a low stony linear bank similar in form to the Iron Age/Romano-British field boundaries that we had recorded in 2018. The alignment of three separate lengths (NY 844661 95726 to NY 84665 95734, NY 84679 95749 to NY 84668 95764 and NY 84717 95808 to NY 84734 95830) matches field boundary R02a shown on the plan of the field system (Figure 1). Whilst these aligned lengths were the only probable remains of the Iron Age/Romano-British field system that we have thus far discovered north of the east-west bank and ditch, it does suggest that the field system extends further north than was identified in 2018.

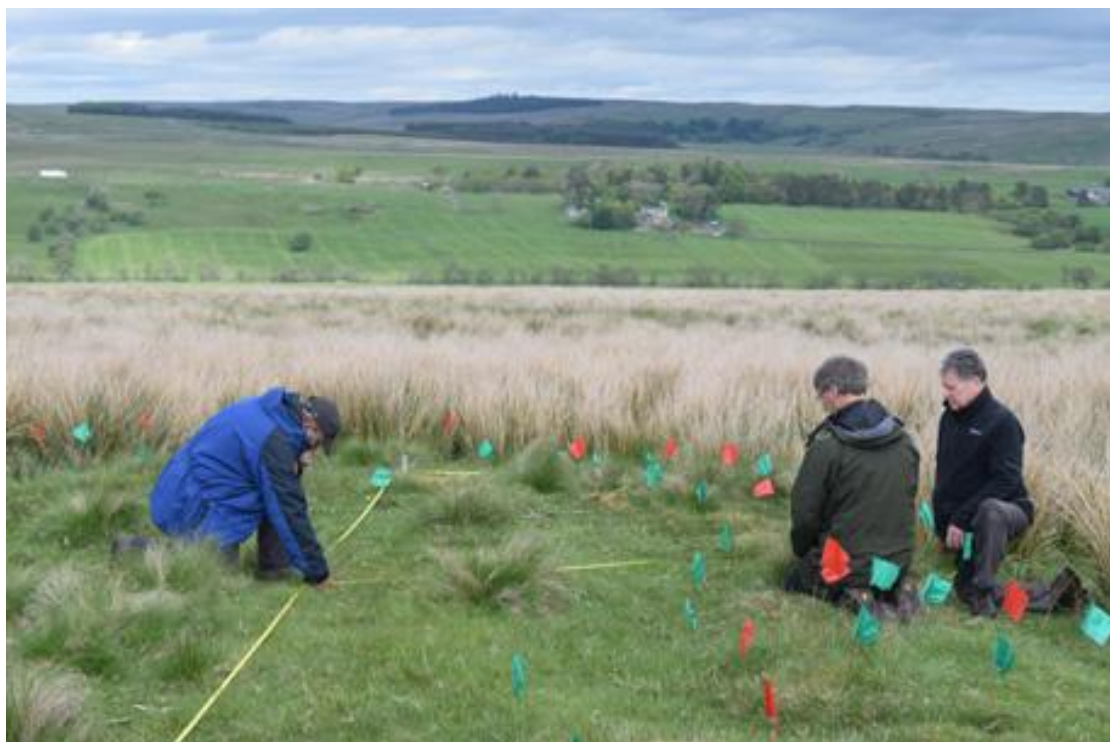
**Fig.11 Tape and offset measurement at R09**

3.16 Having noted similarities between structure R35 and three rectilinear structures with bowed ends, R07, R08 and R09, that we had identified in 2018 located on higher ground at the south-west of the survey area (shown in Figure 1 above) we decided to undertake a detailed measurement of R09 for comparison. This is situated at grid reference NY 84122 95303. The tape and offset surveying method was used.
